# **Test report**

No.: 15-00057-CP-PRG-00

Test of a seat

with regard to Directive / Regulation (EC/EU) / Regulation No. **ECE R14** taking into consideration amendment No. **07**, **Supplement 4** Approval subject: **Strength of safety belt anchorages**

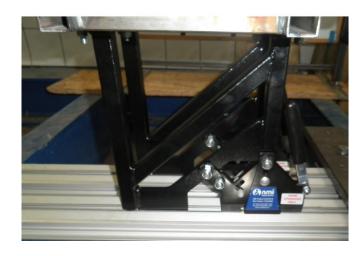
# c) Safety belt anchorages strength test of seat S1NOV04 with leg N0AZM09

# before test

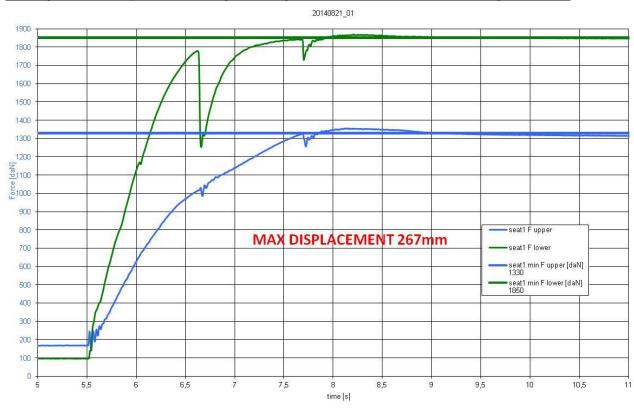
# a) Diagram of safety belt anchorages strength test of seat S1NOV04 with leg N0BLS10

2.1.1. Seat S1NOV04 with leg N0BLS10. Mass of the seat with leg  $m_s$  = 26 kg. Additional force applied  $F_z$  = 20 x  $m_s$  x g (N) as relevant to M1.

| Seat | Forward facing |
|---|---|
| Force in the shoulder belt measured | 13 500 N |
| Force in the lap belt measured | 18 640 N |
| Remark: No ruptures occurred. | |

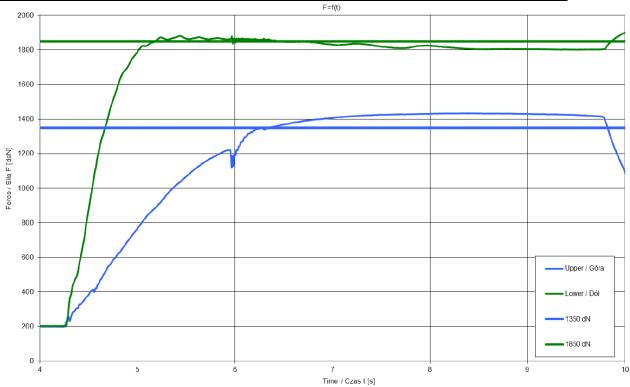
## b) Diagram of safety belt anchorages strength test of seat S1NOV04 with leg N0AZM06

2.1.2. Seat S1NOV04 with leg N0AZM06. Mass of the seat with leg  $m_s$  = 26 kg. Additional force applied  $F_z$  = 20 x  $m_s$  x g (N) as relevant to M1.

| Seat | Forward facing |
|---|---|
| Force in the shoulder belt measured | 14 200 N |
| Force in the lap belt measured | 18 700 N |
| Remark: No ruptures occurred. | |

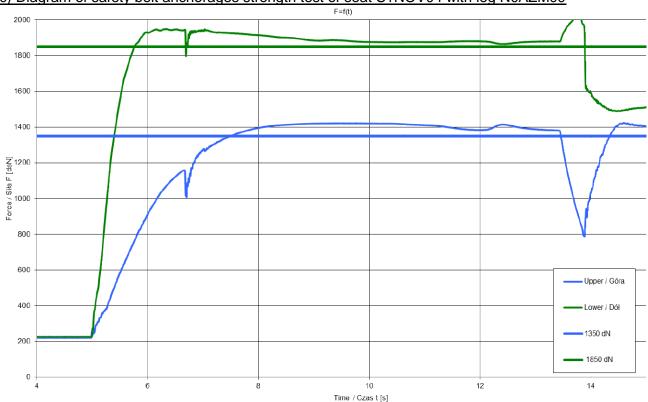
## c) Diagram of safety belt anchorages strength test of seat S1NOV04 with leg N0AZM09

2.1.3. Seat S1NOV04 with leg N0AZM09. Mass of the seat with leg  $m_s$  = 27 kg. Additional force applied  $F_z$  = 20 x  $m_s$  x g (N) as relevant to M1.

| Seat | Forward facing | |
|---|---|--|
| Force in the shoulder belt measured | 13 500 N | |
| Force in the lap belt measured | 18 600 N | |
| Remark: No ruptures occurred. | | |

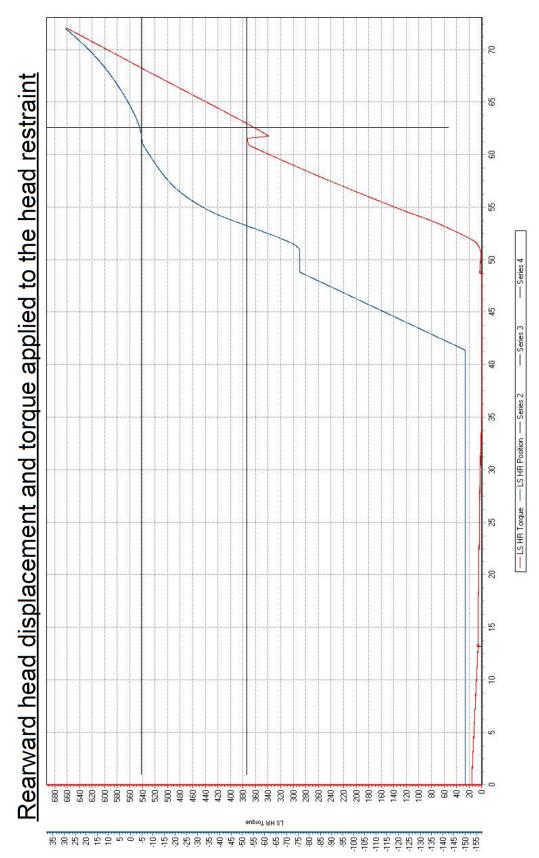
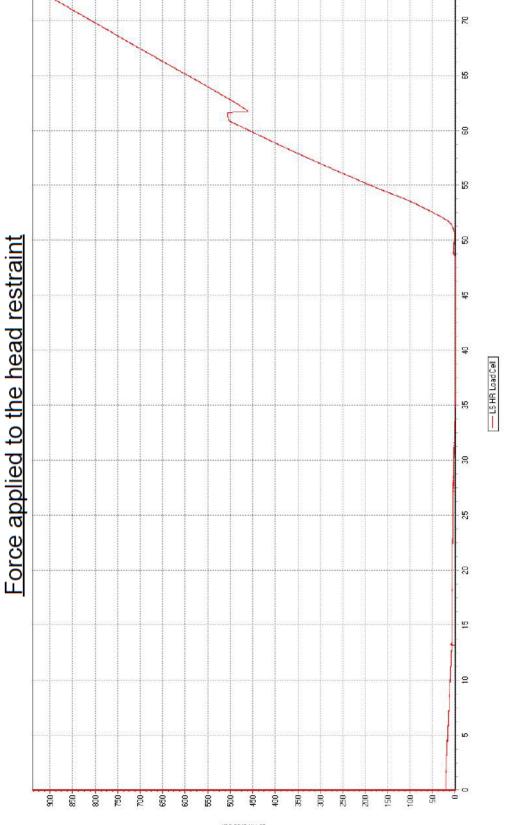
## d) Diagram of head restraint performance test

| | Paragraph | | Measured values |
|--|---|---|--|
| Head rearward displacement X < 102 mm when loaded to moment 373 Nm around R point | 5.12. | <i>6.4</i> . | -4,8 mm* |
| Loading force for head restraint F ≥ 890 N | 5.13. | 6.4.3.6. | 890 N without rupture |

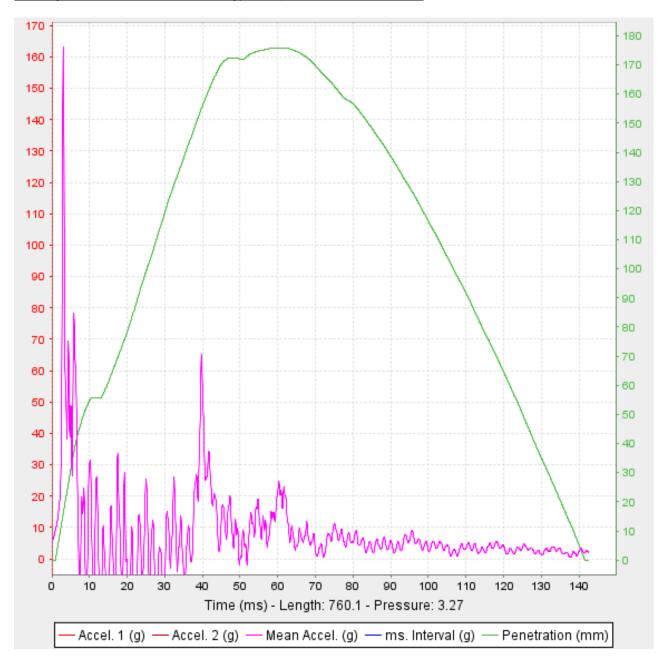
## e) Diagram of head restraint energy dissipation test - front, 90°

| | Paragraph | | Measured values |
|--|---|---|--|
| the deceleration of the headform | 5.5 | 6.8.1.1.3., | Front head restraint surface: |
| ≤ 80 g continuously for more than 3 ms under the impact* | 5.5. | Annex 6 | max. 163 g at 24,2 km/h, 3 ms criterion was impossible to calculate, see diagram e) in point 3.3 |

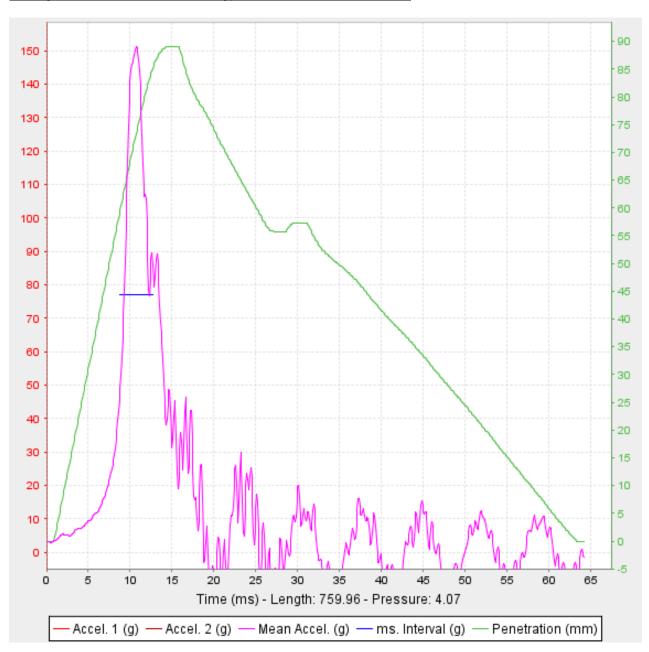
## f) Diagram of head restraint energy dissipation test - rear, 45°

| | Paragraph | | Measured values |
|--|---|---|--|
| No additional cause of danger to | | | Rear head restraint surface: |
| occupants of the vehicle by the head restraint; energy absorption - | | | max. 76,9 g for 3 ms at 24,3 km/h |

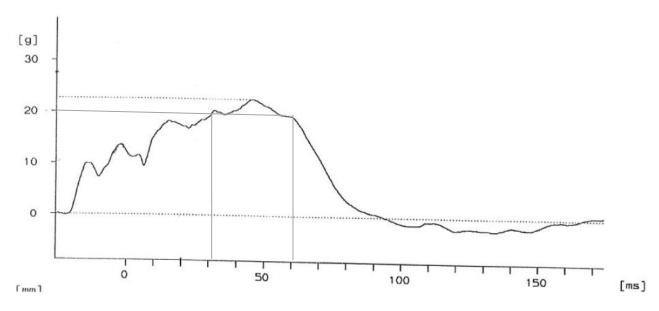
# g) Deceleration of sled test trolley - frontal impact

| | Requirement | Measured |
|---|---|---|
| Deceleration | 20g for 30ms | Achieved |

| 5.2.5 | There was no failure of the seat frame or seat anchorage, adjustment and displacement systems or their locking devices during the test |
| 5.2.6. | There was no release of the locking systems during the tests |

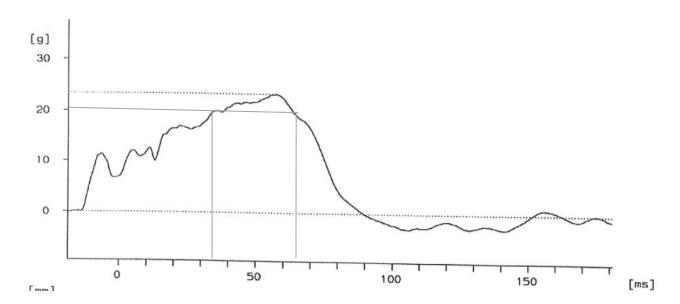
# h) Deceleration of sled test trolley - rear impact

| | Requirement | Measured |
|---|---|---|
| Deceleration | 20g for 30ms | Achieved |

| 5.2.5 | There was no failure of the seat frame or seat anchorage, adjustment and displacement systems or their locking devices during the test |
| 5.2.6. | There was no release of the locking systems during the tests |
